# Manhole Inspection Summary

Manhole # S09EE2022MH

Insp Date: **9/26/06 1:55 PM**

**Location** Address: **6225 PIMILICO RD**

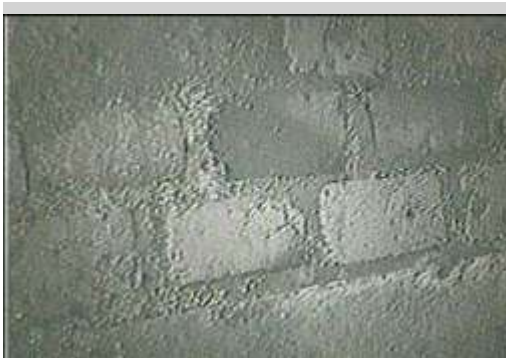
Defect

Infiltration: ☐ None ☒ **Joint** ☐ Cracks ☒ **Mortar** ☐ Roots ☐ Wall

Adjustment infiltration.

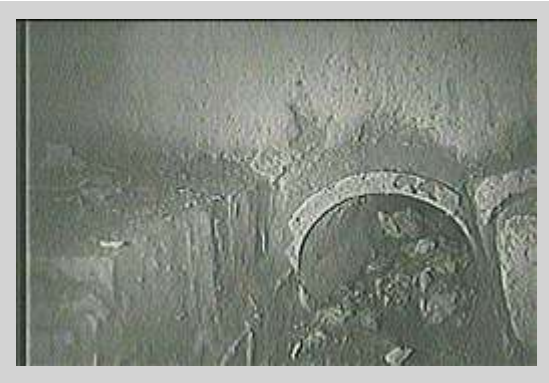
### 8 in. Circular Gravity Sewer Pipe Out @ 12 O'Clock

Deposits: ☐ None ☐ Mud ☐ Sludge ☒ **Debris** ☐ Grease

Silt Depth: **2** (in.) Deposits Extent: **Medium**

Infiltration: **Evidence** Pipe Seal Cond: **Unknown**

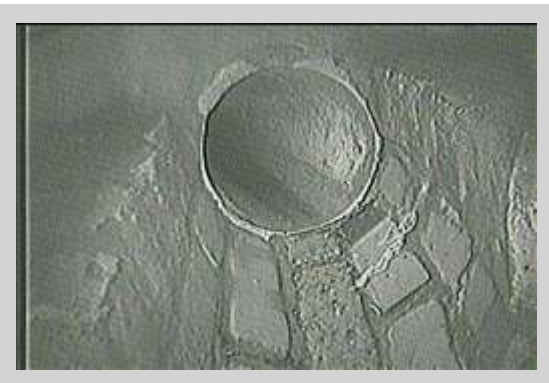
### 8 in. Circular Gravity Sewer Pipe In @ 3 O'Clock

Infiltration: **Evidence** Pipe Seal Cond: **Unknown**

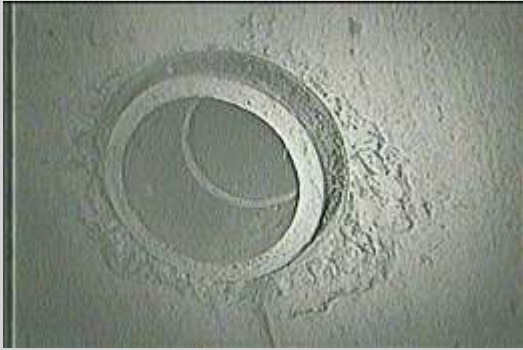
Pipe In @ 6 O'Clock

Pipe Seal Cond: **Roots**
